PRELIMINARY REPORT  
OF THE  
**EXCAVATION OF THE  
"TEAHOUSE RUINS"**

ARDENWOOD HISTORIC FARM  
FREMONT, CALIFORNIA

GEORGE R. MILLER, PH.D.  
DEPARTMENT OF ANTHROPOLOGY  
CALIFORNIA STATE UNIVERSITY, HAYWARD  
OCTOBER 14, 1988

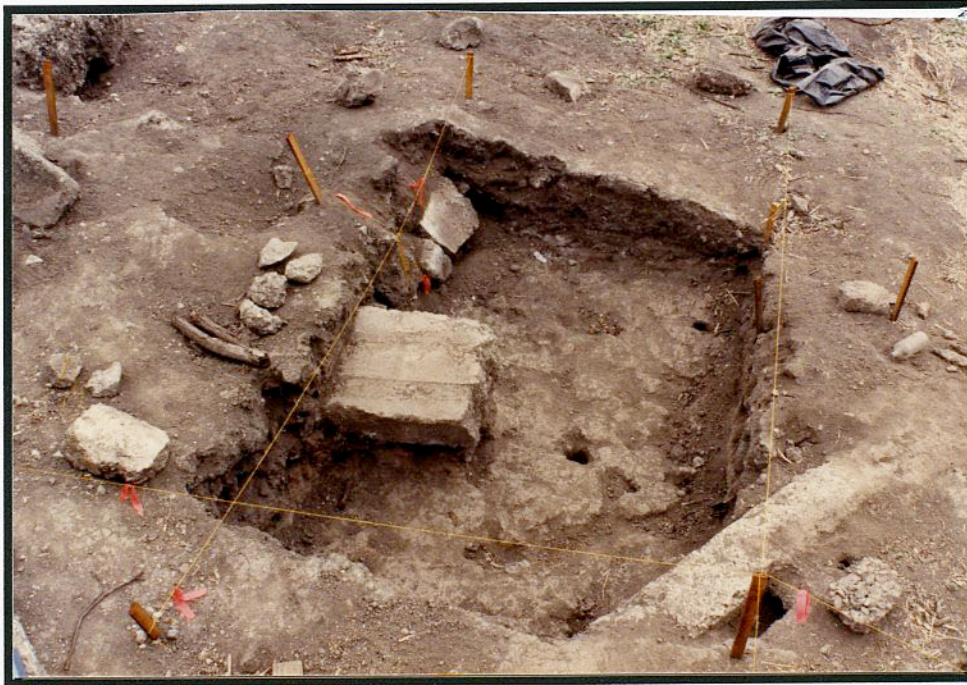
**Figure 6** Unit 2E2S upon completion of excavation

Sterile soil was encountered in Unit 2E2S at approximately 70 cm. below the top of the foundation. At this same depth (28 inches) the foundation wall was found to end; beneath it was found sterile hard packed clay, apparently the subsoil on which concrete had been poured (see Figure 6).

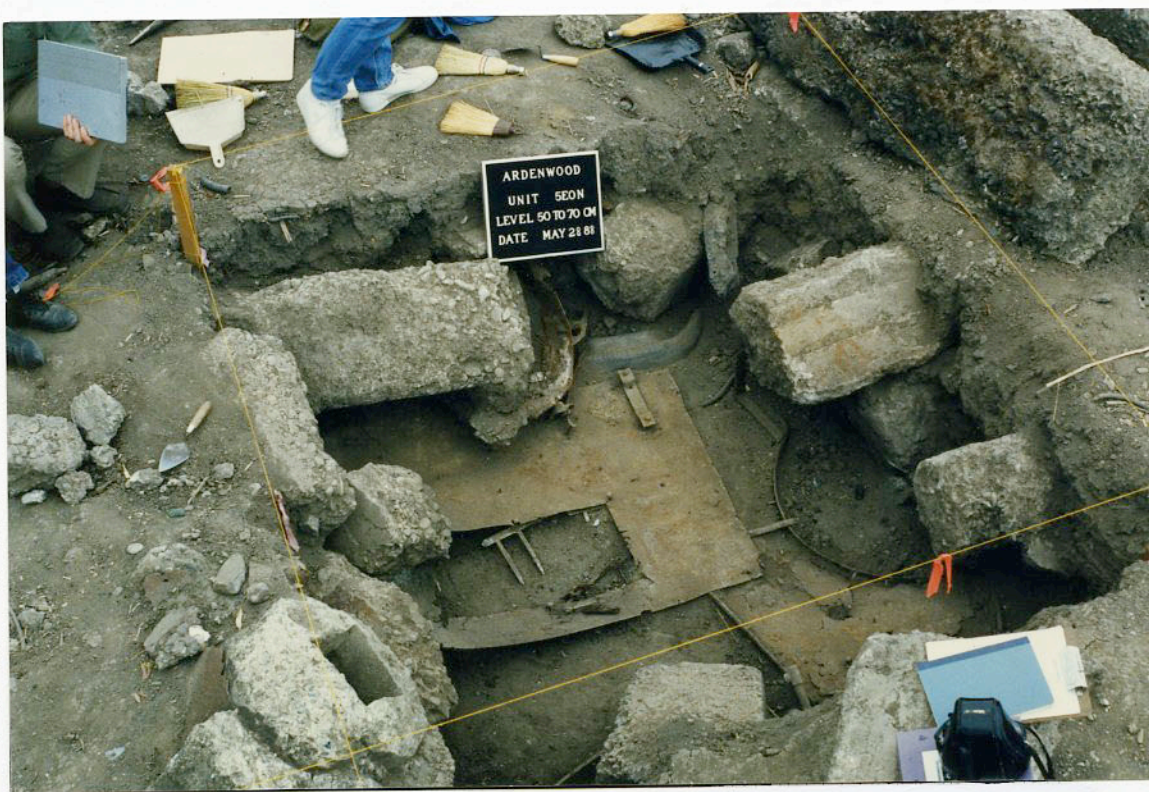
Figure 7 Unit 5E0S upon completion of excavation.

5E0S -- This unit was the only one not positioned to overlap a foundation wall and hence it provides a sample of the deposit at the center of the foundation cavity. Aside from two solid brass hooks of possible Japanese origin, found near the surface, Unit 5E0S yielded no cultural remains associated with the Japanese Commissioners' Office. Instead, the deposit was characterized by artifacts similar to the farm trash encountered in Unit 2E2S discussed above. Charcoal and molten stratified glass were common in the upper levels along with a large portion of the skeleton of a domestic dog; the lower levels were dominated by an abundance of rusted car parts (door latch mechanism, wet cell battery remnants, the back wall of a truck cab and an automobile tire) (see Figure 7). Excavation of Unit 5E0S had to be

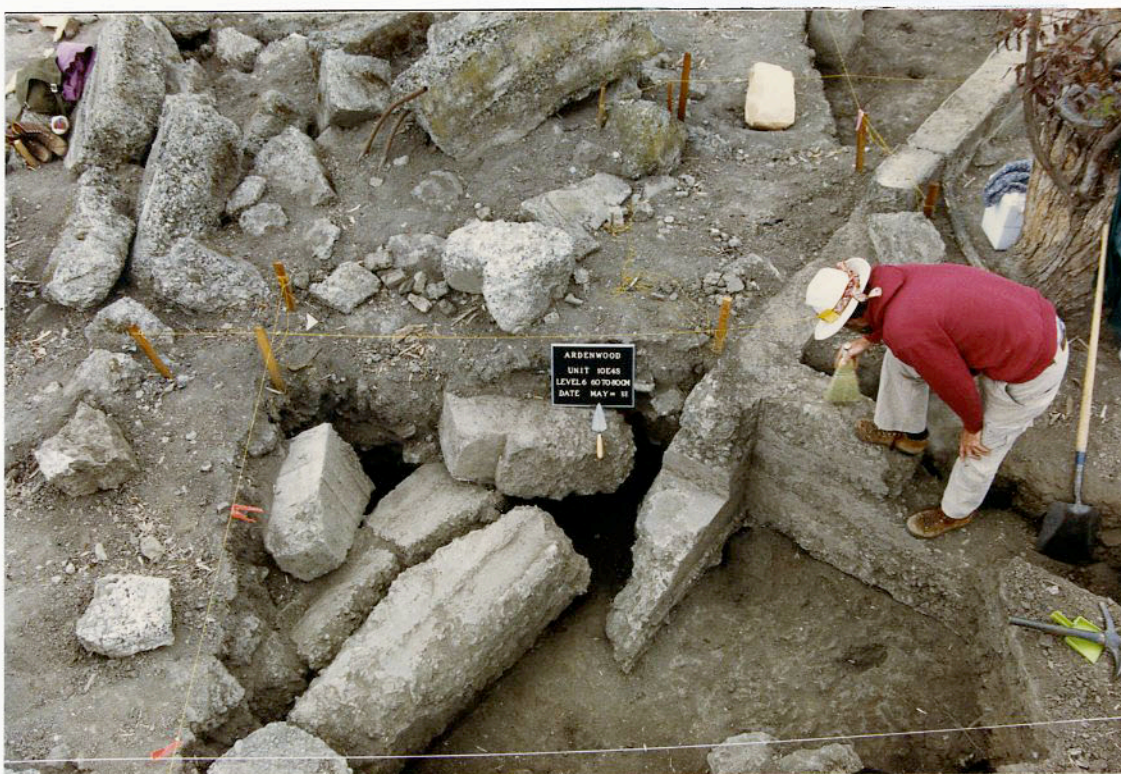
*Figure 8 Unit 10E4S upon completion of excavation.*

ered by Unit 10E4S, and its 1m. x 2 m. southern extension (Figure 8). Along with numerous nails, wood chunks, window glass and molten glass fragments, large quantities of dark grey to black, burnished, ceramic roof tiles as well as several decorative brass plates were encountered in this area. The tiles (discussed in detail below) are identical to those found occasionally in other units but their overwhelming abundance here along with large quantities of fine cement mortar suggests that Unit 10E4S was located in a section of the original structure which had been heavily tiled. As will be demonstrated below, these tiles and other foundation evidence strongly suggest this area of the structure as the canopied entrance way or "carriage porch".

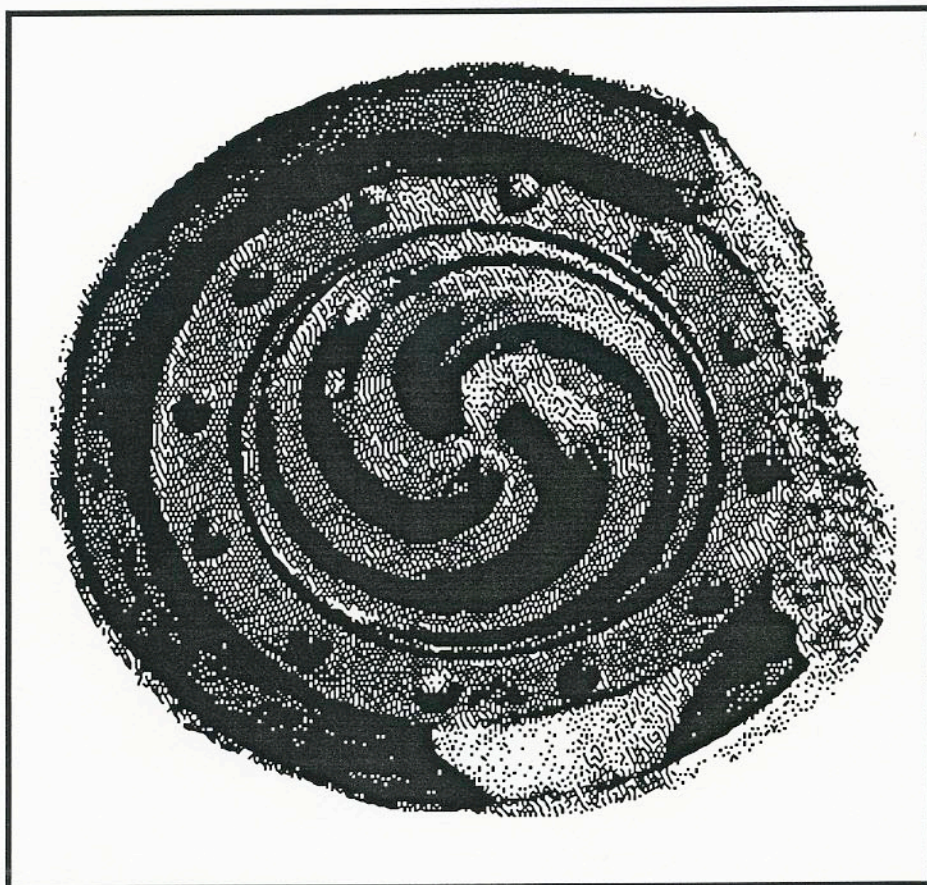
Figure 13 *Mitsu-tomoyé cap tile*<sup>3</sup>

2) Mitsu-tomoyé cap tiles -- Certainly the most distinctive roof tiles recovered in the excavation were a number of black ceramic cylinders each with one highly decorated disc-shaped end. Since all the specimens were found at least partially fragmented, the length of the original cylinder must be estimated at between 15 and 20 cm. The ornamental end has a diameter of some 11.5 cm. and is decorated with a triple-lobed, swirling design, cast in low relief (Figure 13). This design,

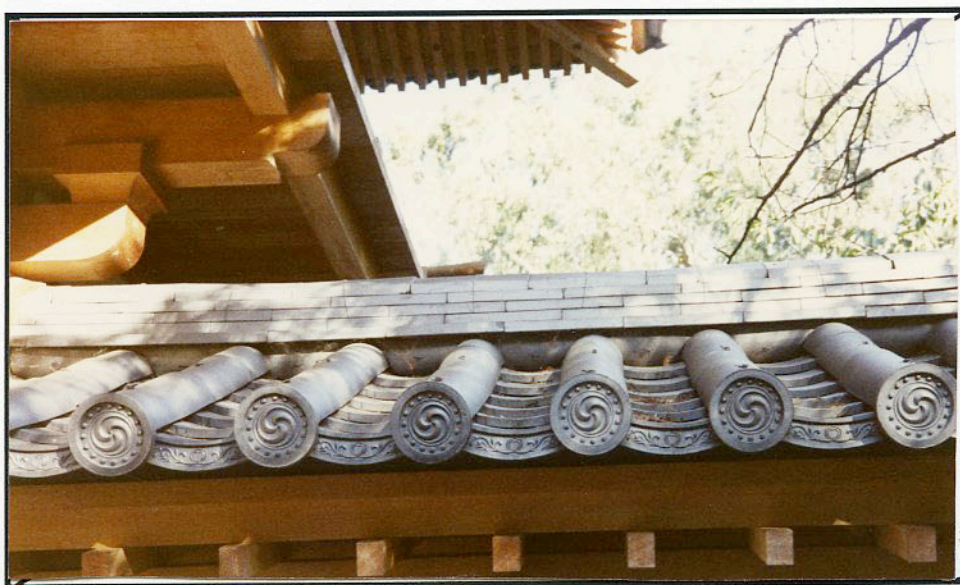
Figure 14 *Mitsu-tomoyé tiles installed on the eaves of the entrance gate to the Japanese Tea Garden, Golden Gate Park.*

The placement of the *mitsu-tomoyé* tiles on the Japanese Commissioners' Office roof, although impossible to confirm with known photographs, was probably associated with the highly ornamented gable ends. Their size and elegance certainly would have allowed them to fit comfortably into the positions of the circular ornaments which can be discerned above the carriage porch entrance in Plates 1 through 5. The *mitsu-tomoyé* tiles seem not to have been placed on the Japanese Commissioners' Office roof in the manner in which they are still seen on the roof of the Hagiwara Gate of the Japanese Tea Garden in Golden Gate Park. There the identical *mitsu-tomoyé* tiles linked by floral *yedo* tiles form a repetitive motif which overhangs the eaves (Figure 14).

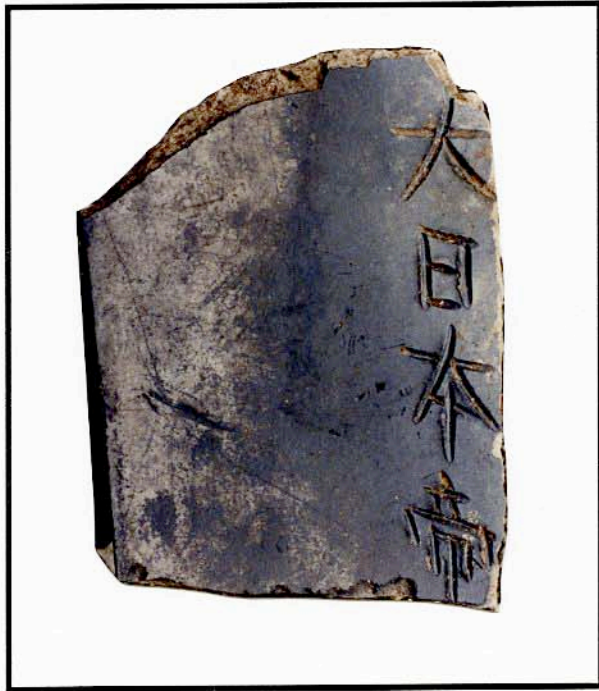
**Figure 16** *Roof tile incised with characters translated as "Great Japanese Empire."*

4) "Japanese Empire" tile -- A unique specimen in the collection is a tile fragment that bears four incised Japanese characters which would have been translated as "Great Japanese Empire" when complete (Figure 16). Although fragmentary (approximately 11 cm. long by 8 cm wide by 1.5 cm. thick), it is clear that this tile would have been much larger and the original inscription may have included more characters. The tile is flat and may have served the same role as the border tile to the curved coping tiles illustrated in Figure 11.

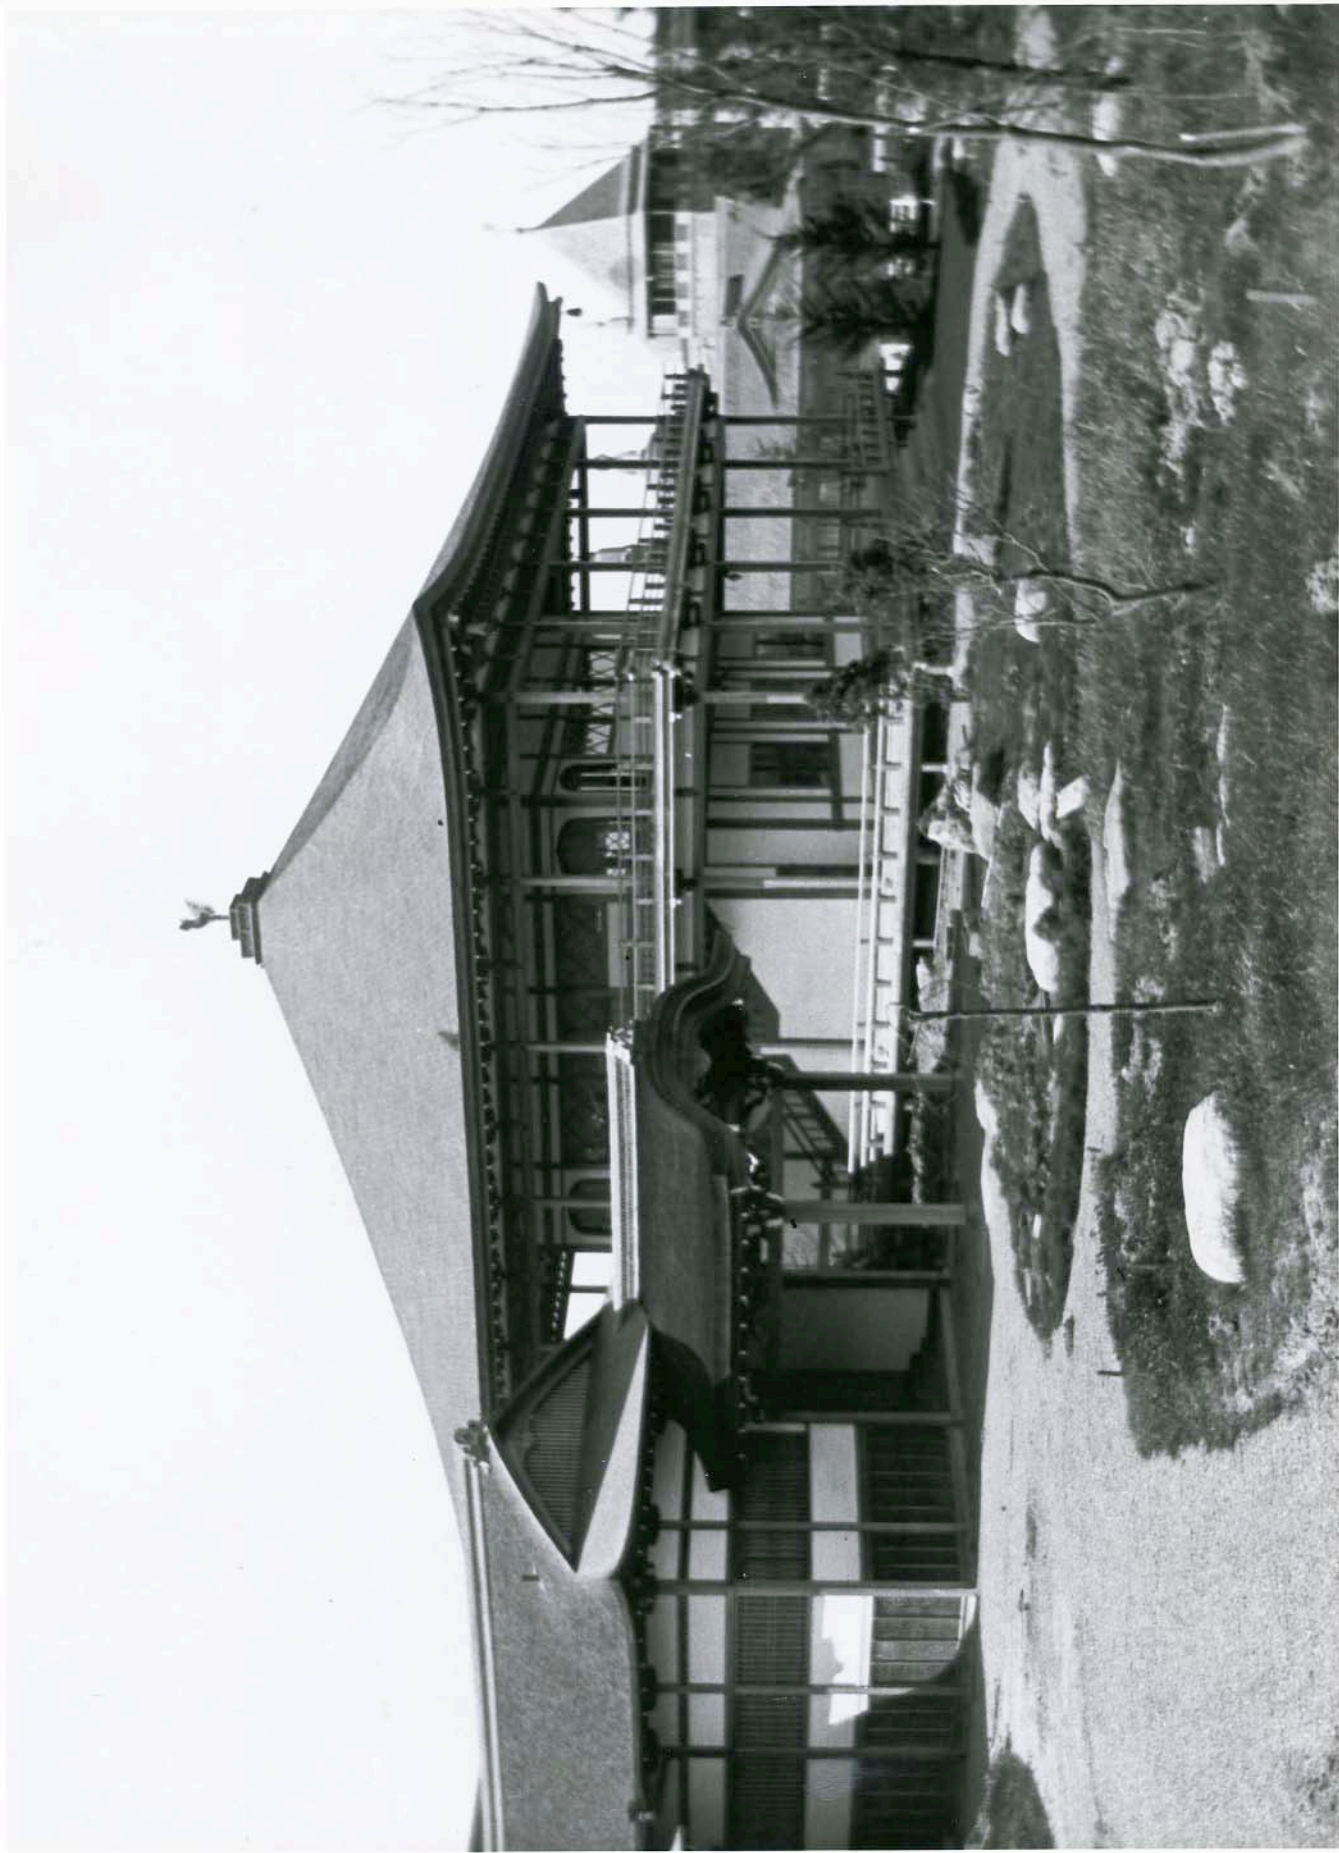
Plate 1

PLATE 1 -- The entrance way of the Japanese Commissioners' Office (left) and attached Reception Hall (center) *in situ* at the Panama Pacific International Exposition in San Francisco. The photograph appears to date to sometime after the closure of the Exposition (winter 1916?) judging by the slightly overgrown vegetation and leafless trees. This photo may have been used by Thayer Hall as an advertisement for Clara Patterson Layson.

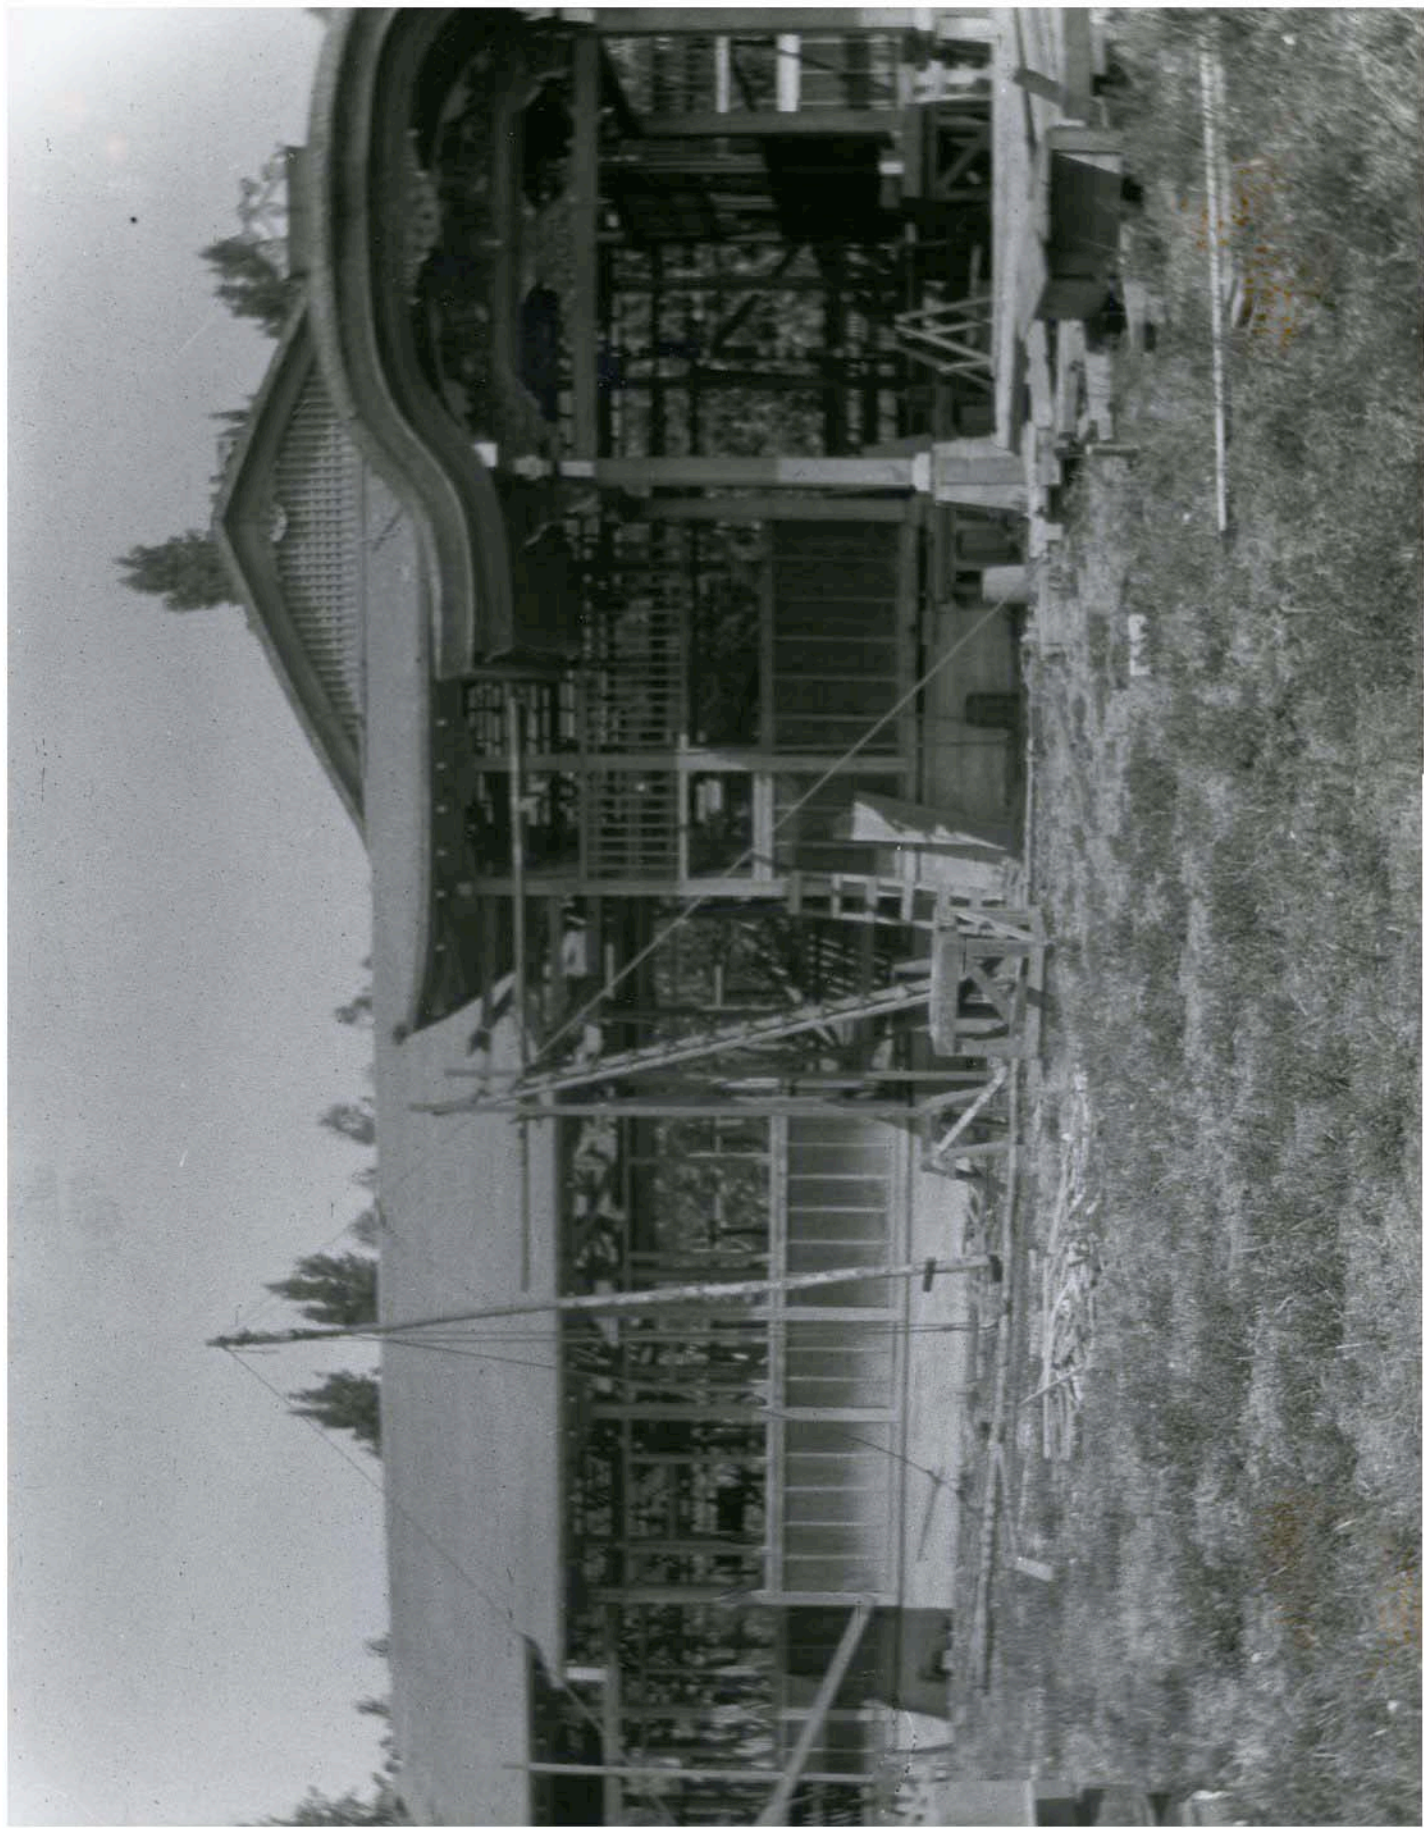
Plate 2

PLATE 2 -- A photo of early reconstruction of the entrance way of the Japanese Commissioners' Office at Ardenwood taken from the southeast (late 1916/early 1917?).

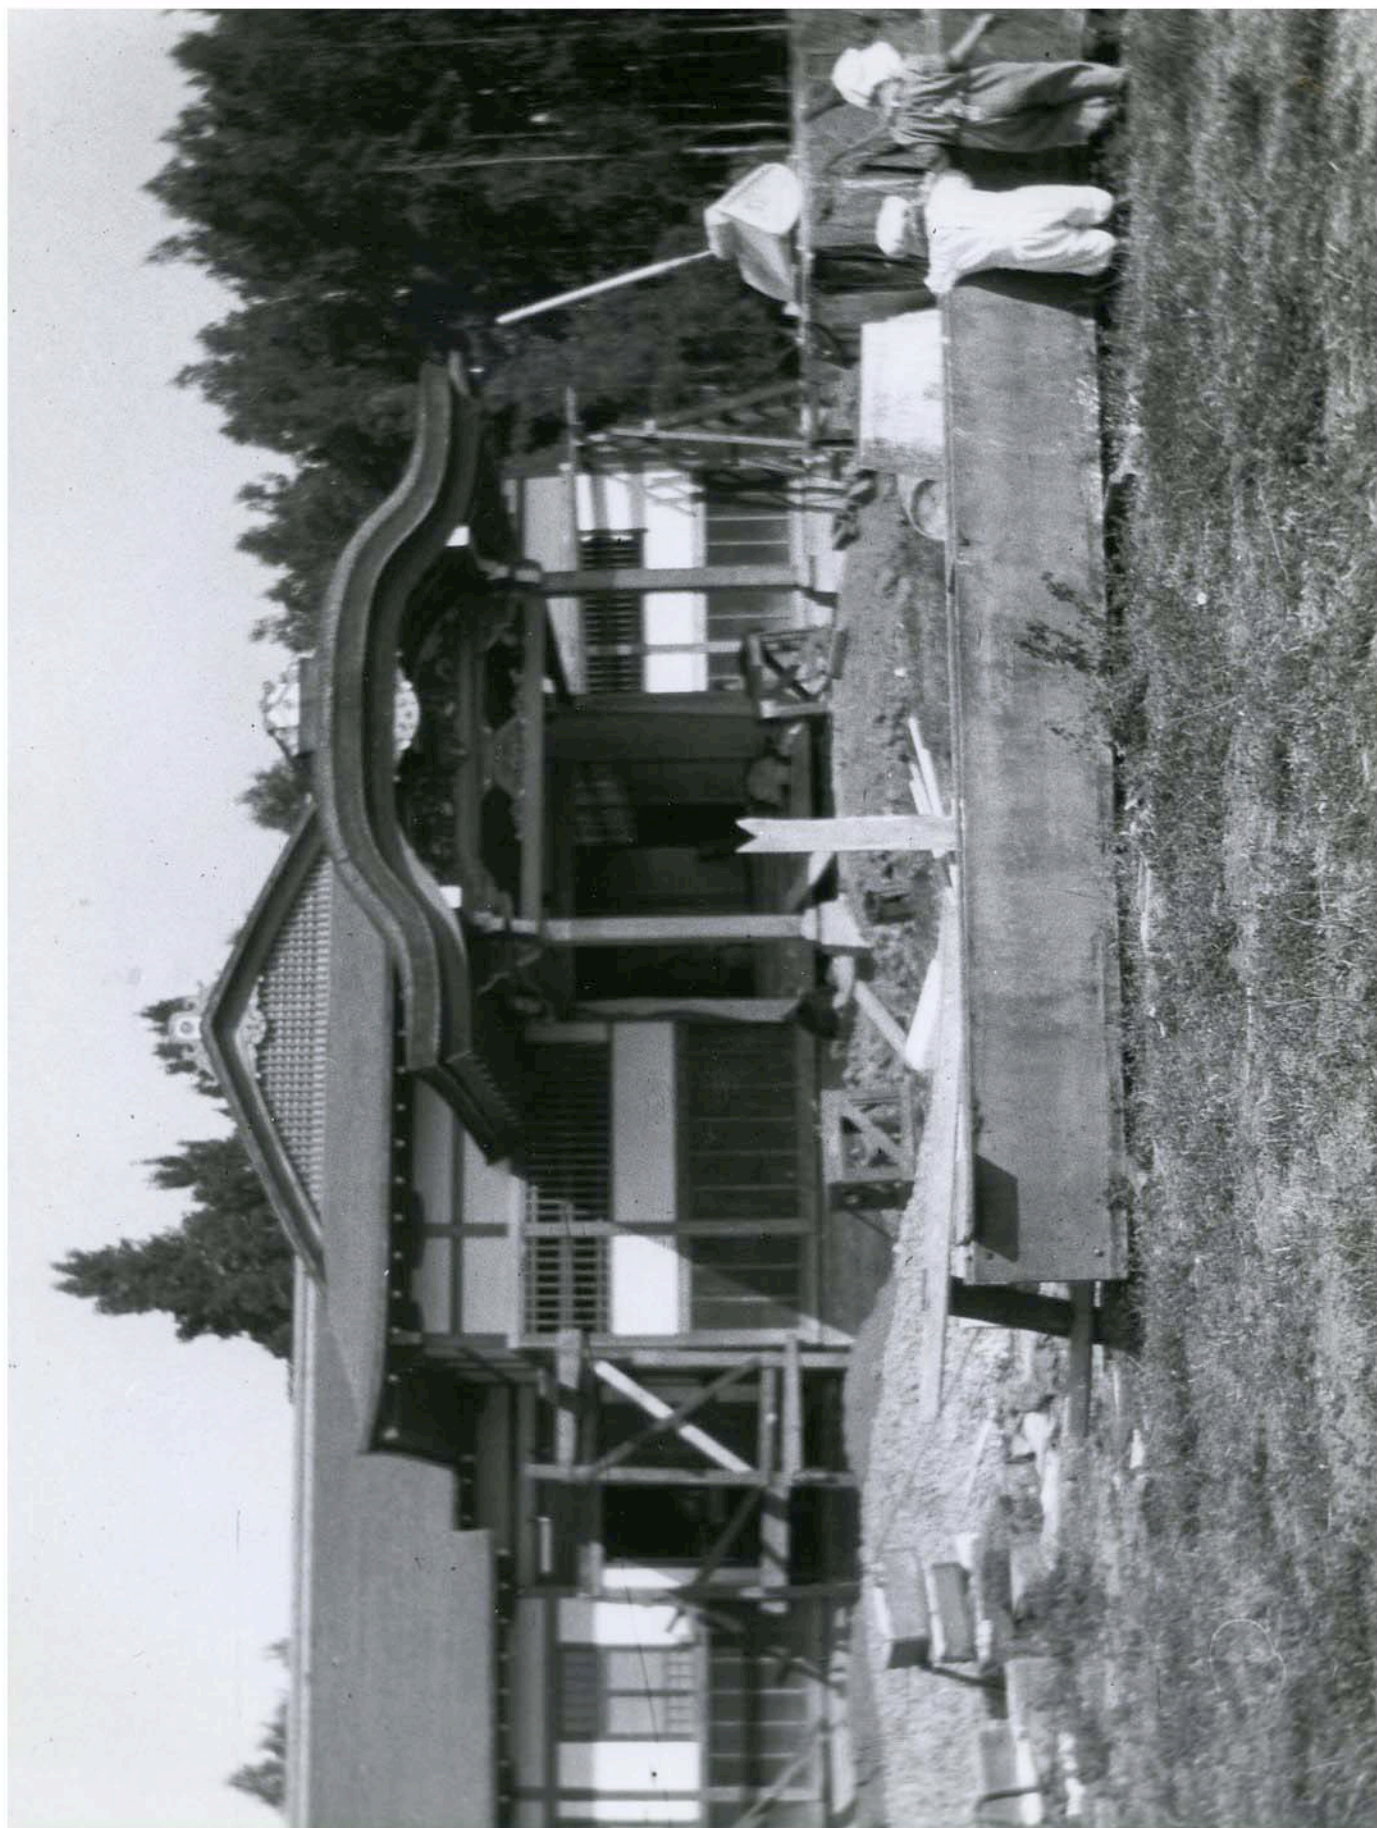
Plate 3

PLATE 3 -- A somewhat later photo of the entrance way of the Japanese Commissioners' Office under reconstruction at Ardenwood taken from the southeast (late 1916/early 1917?). Note the North Wood eucalyptus trees in the background and the small children in the foreground. The children may be those of Henry Patterson, who had married in 1913 and begun raising a family in the "Big House."

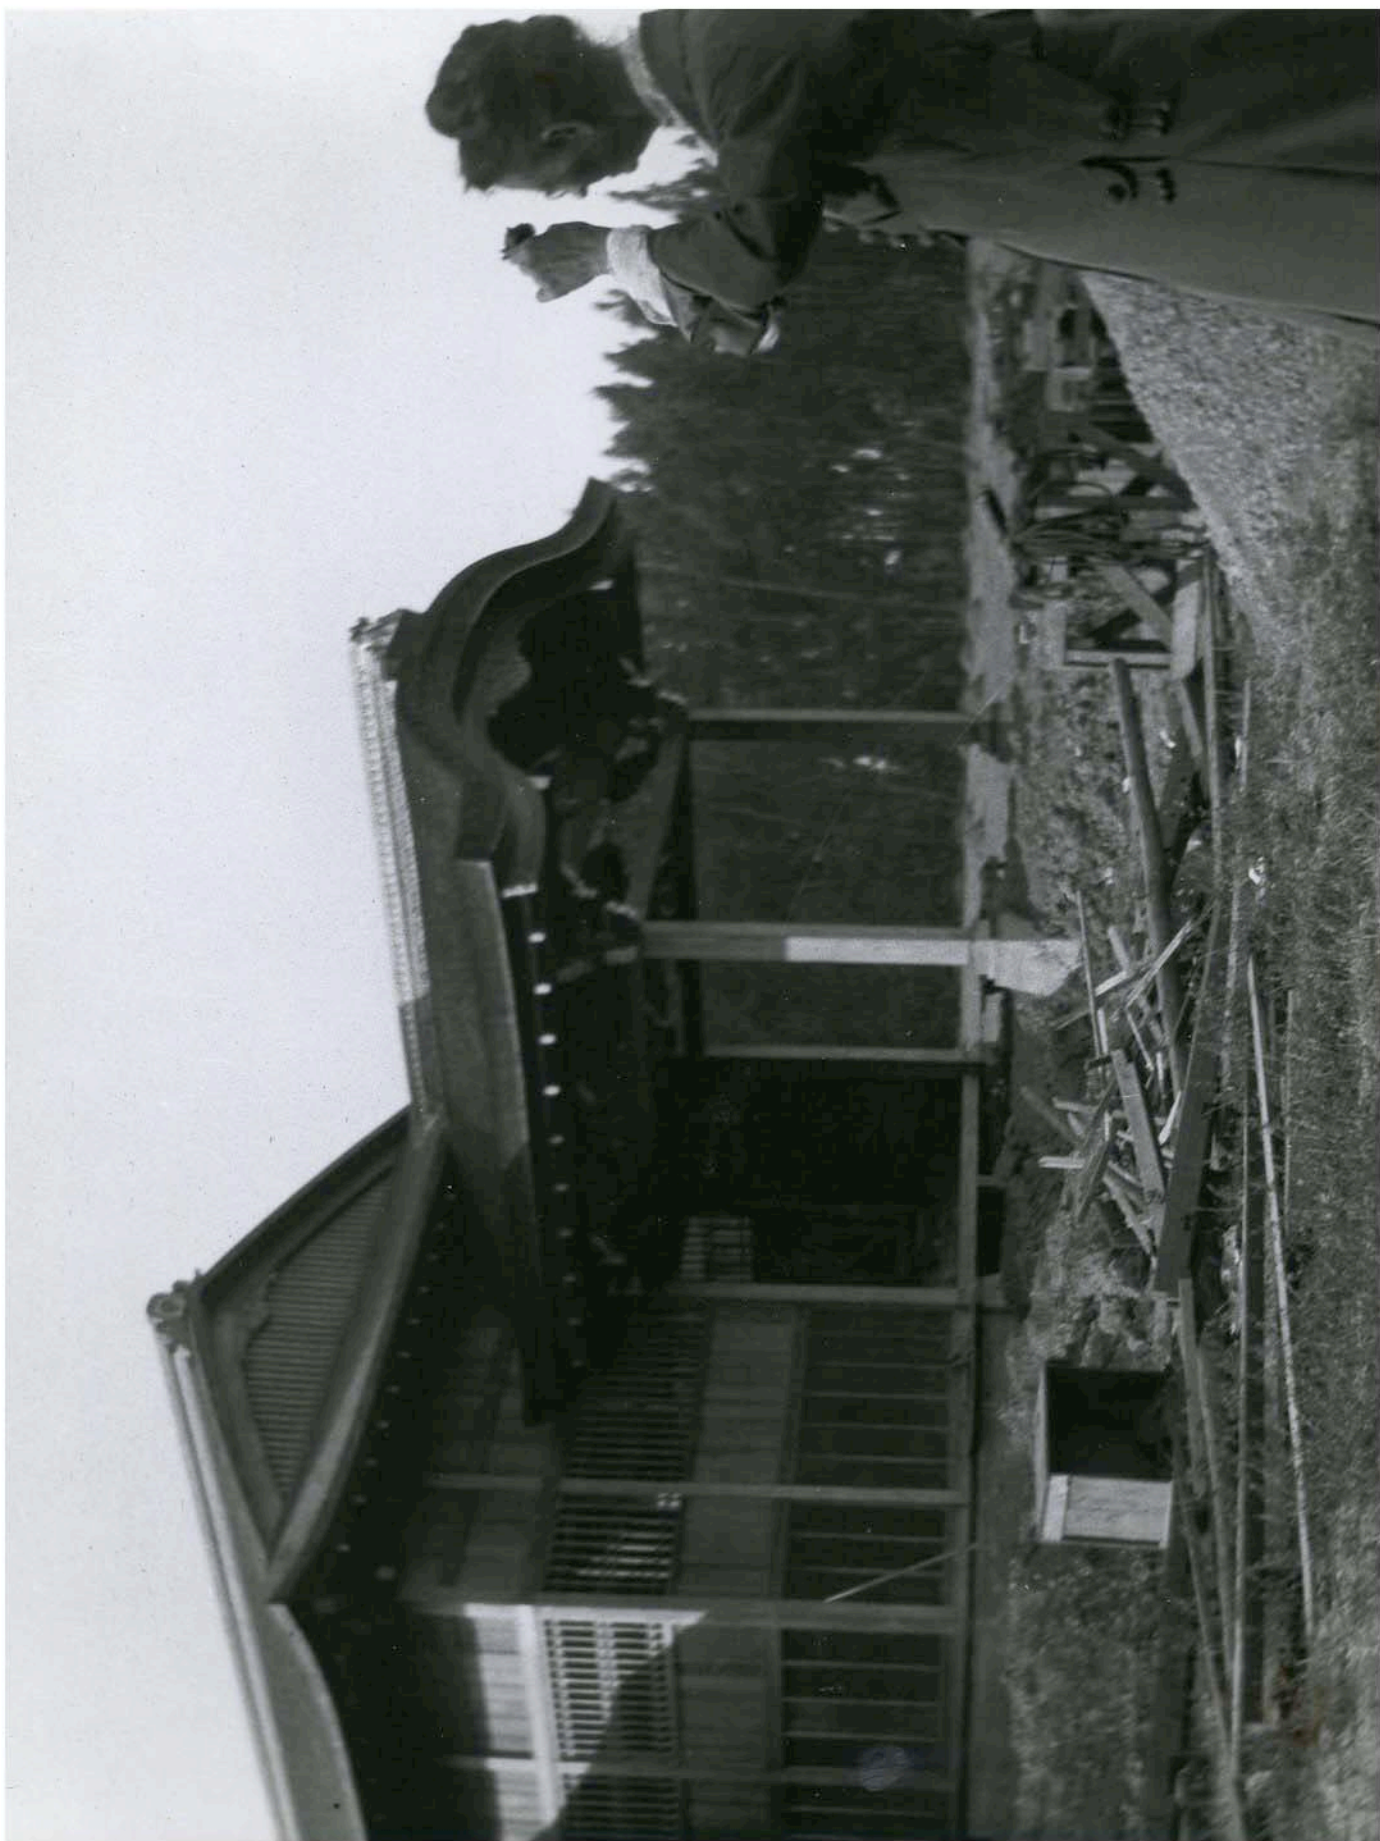
Plate 4

PLATE 4 -- The entrance way of the Japanese Commissioners' Office under reconstruction at Ardenwood taken from the south with Clara Patterson Layson in the foreground (late 1916/early 1917?).

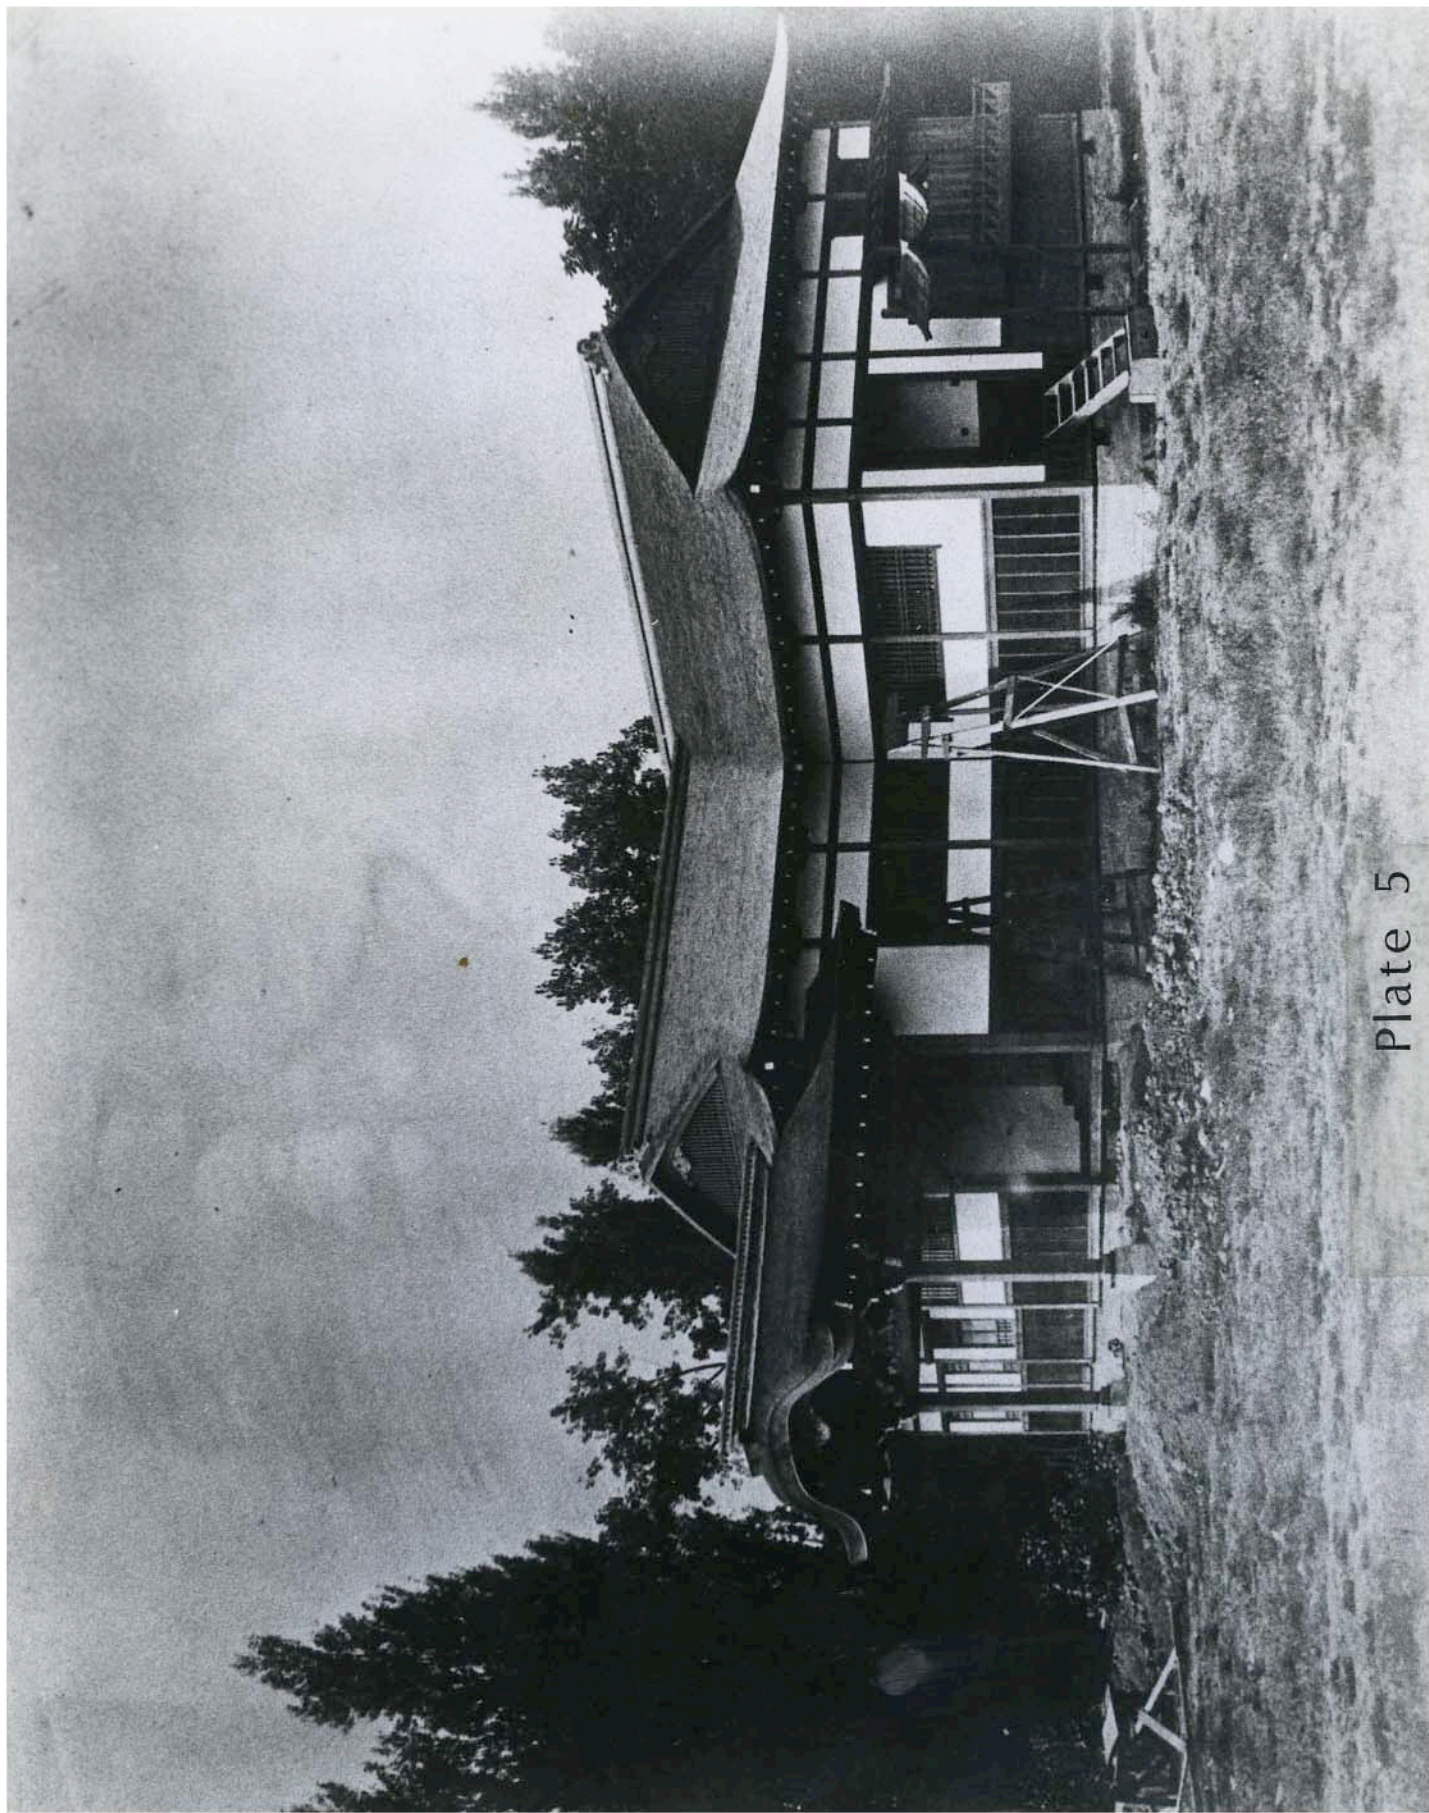
Plate 5

PLATE 5 -- The entrance way of the Japanese Commissioners' Office under reconstruction at Ardenwood taken from the northeast (late 1916/early 1917?).

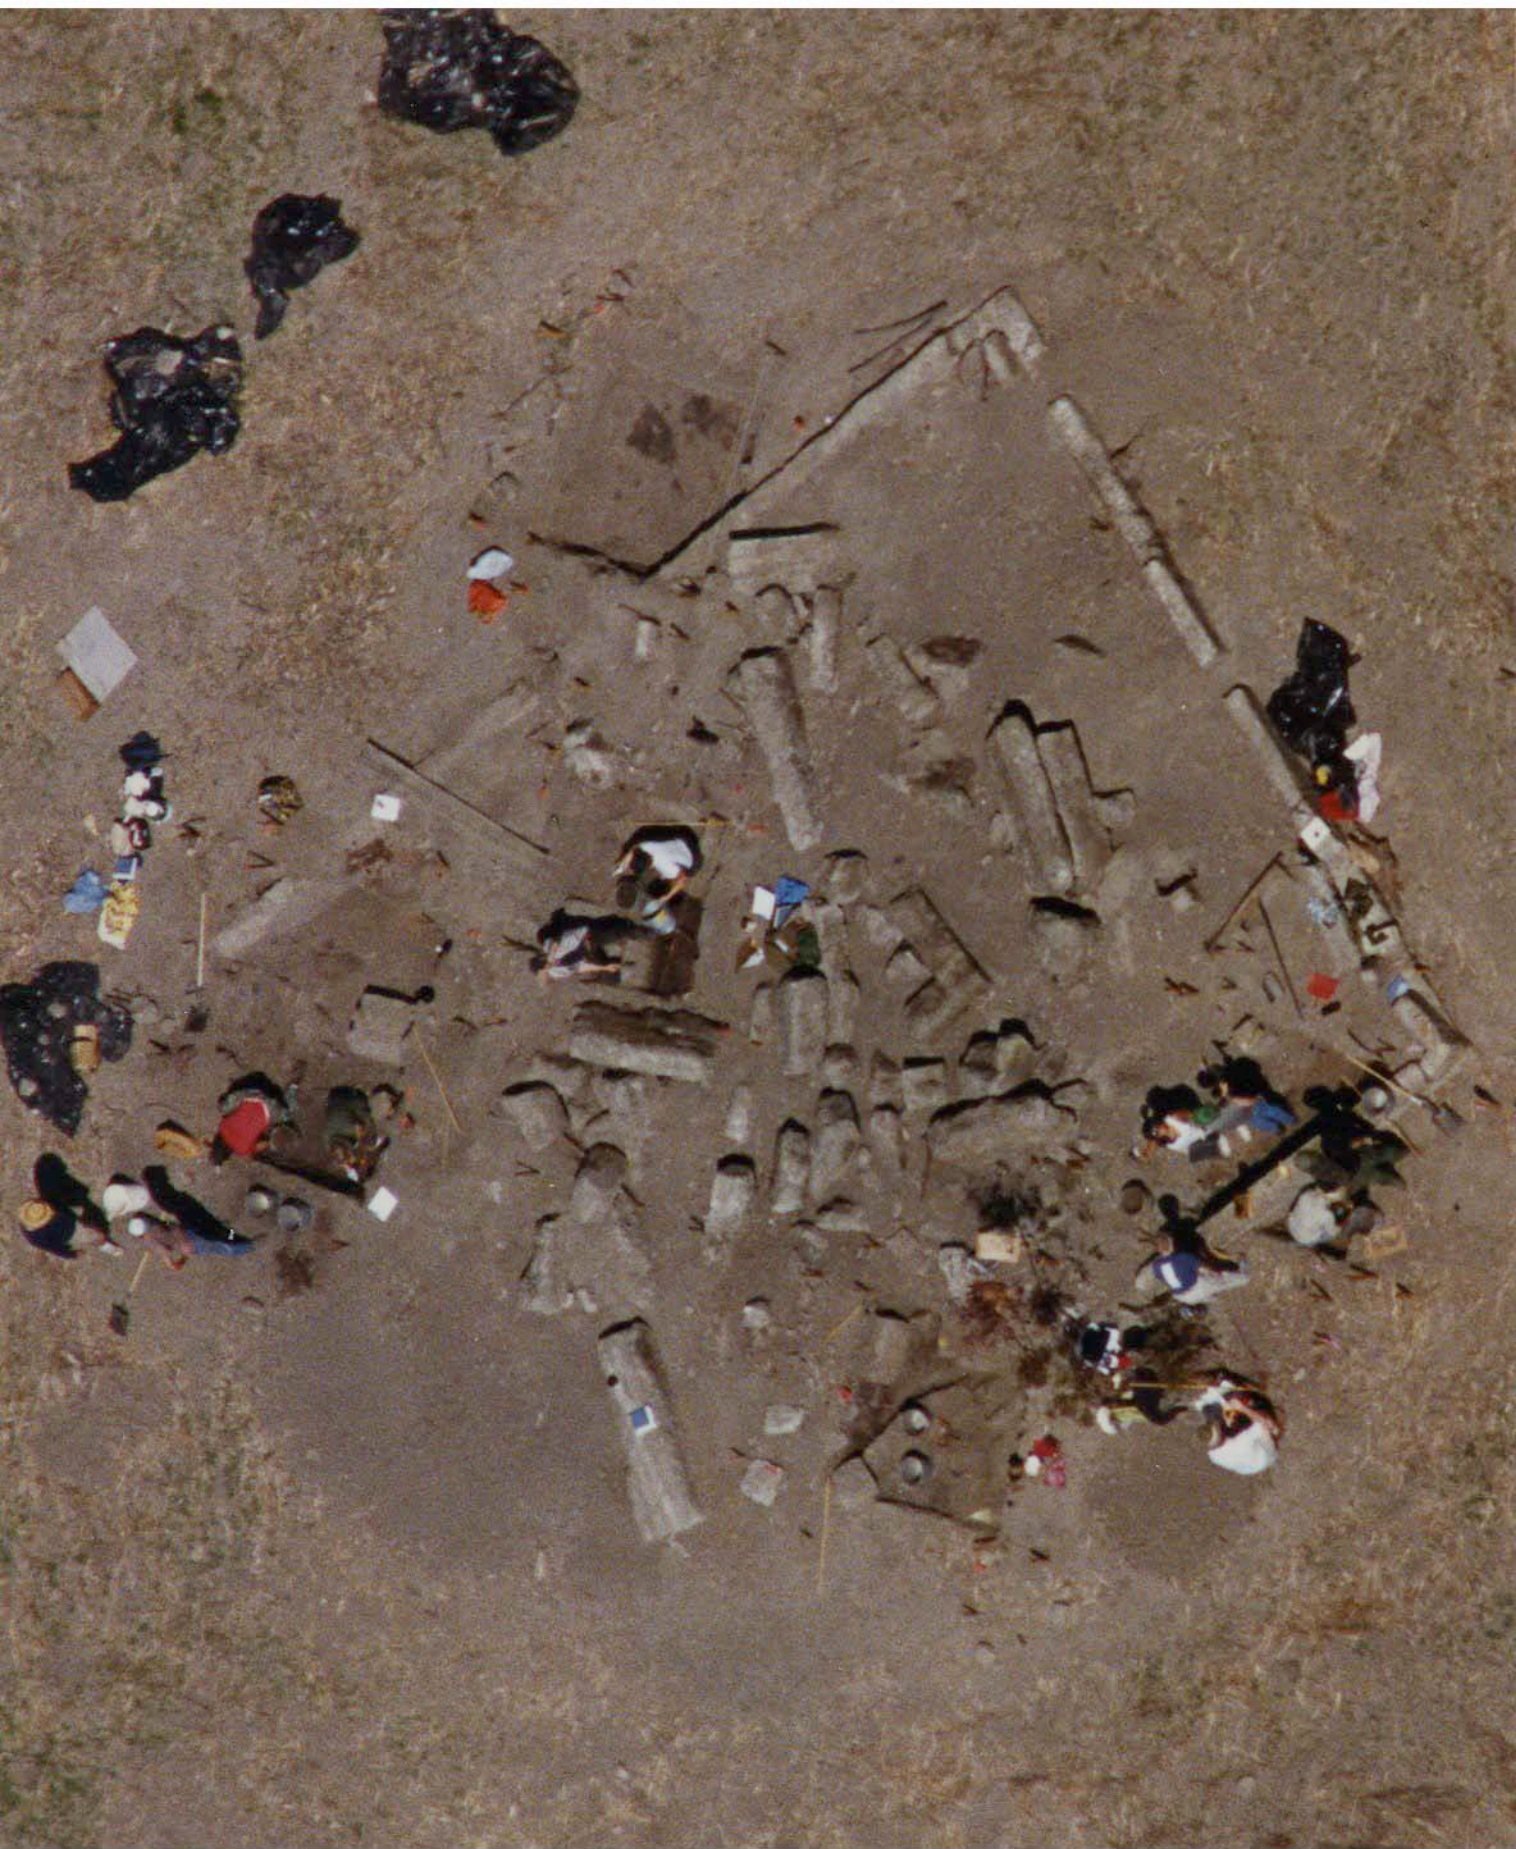
Plate 6

PLATE 6 -- Aerial photo of "Teahouse Ruins" under excavation on May 14, 1988. Note large quantities of foundation rubble not shown in Figure 5.
